APPENDIX 1.

1. COMMISSIONING INSPECTION TO ENSURE THE SAFETY OF THE INSTALLATION AND RELATED DOCUMENTATION

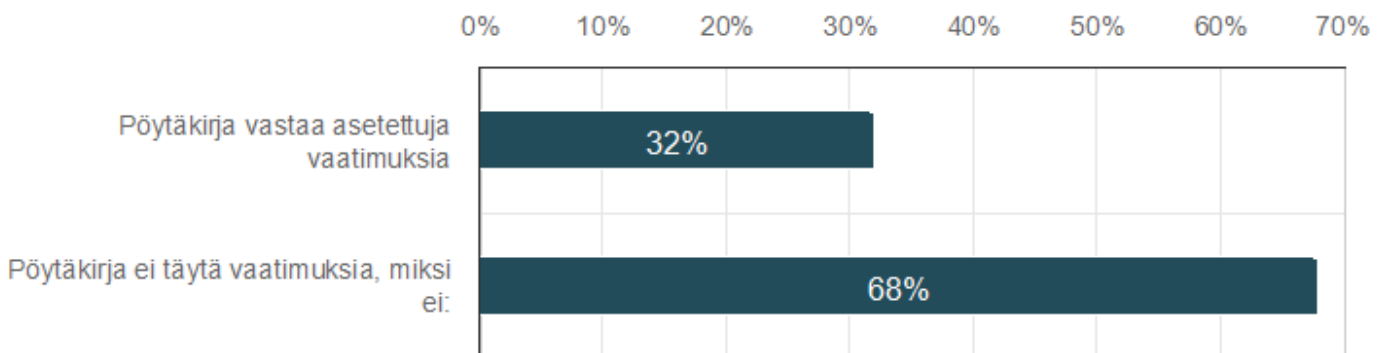
- The record was index form ST 55.36 from the ST card system, Section 1 of which states that the inspections according to SFS 6000-6 are in order and refers to the separate inspection record template ST 51.21.05 regarding the AC part of the system. However, the record template in question was not available for the installations (measurement results of the AC part).
- According to the possessor, no commissioning inspection record for the photovoltaic installations was delivered. The site has AC panels, and therefore the DC part inspections and tests are not required.
- The inspections required for a commissioning inspection in Part 6 of SFS 6000 had been inadequately performed or presented in the record.

- No record of inspections in accordance with SFS 62446-1 was available. The version of SFS-6000 used had not been specified.
- The only measurements performed were system insulation resistance (3.56 mΩ; not specified whether the measurement was on the AC or DC side), final circuit's short-circuit current (767 A) and continuity of earthing 0.3 Ω (not specified whether the measurement applied to the continuity of the AC final circuit protective conductor). No measurements in accordance with SFS-EN62446-1 in the DC part were documented.

- The name and contact details of the supervisor of electrical works were not indicated in the record. The record did not include the tests and inspections in accordance with SFS 6000 712.6.101 (in accordance with SFS-EN 624461-1).

- There were no DC-side measurements, no visual inspection, no reference to the standards used.
- Name and contact details of the supervisor of electrical works were missing. An overview of visual inspections was missing. The required measurements and tests were incomplete.

- The name and contact details of the supervisor of electrical works were missing. Some of the AC side measurements were missing. The section in the record on whether the installation meets the SFS 6000 requirements had not been completed. All measurement results from the DC side were missing. The visual inspections did not determine whether they applied to the AC or DC side, etc. The record was named 'Photovoltaic system commissioning inspection record'. The work site and work area had not been delimited either.

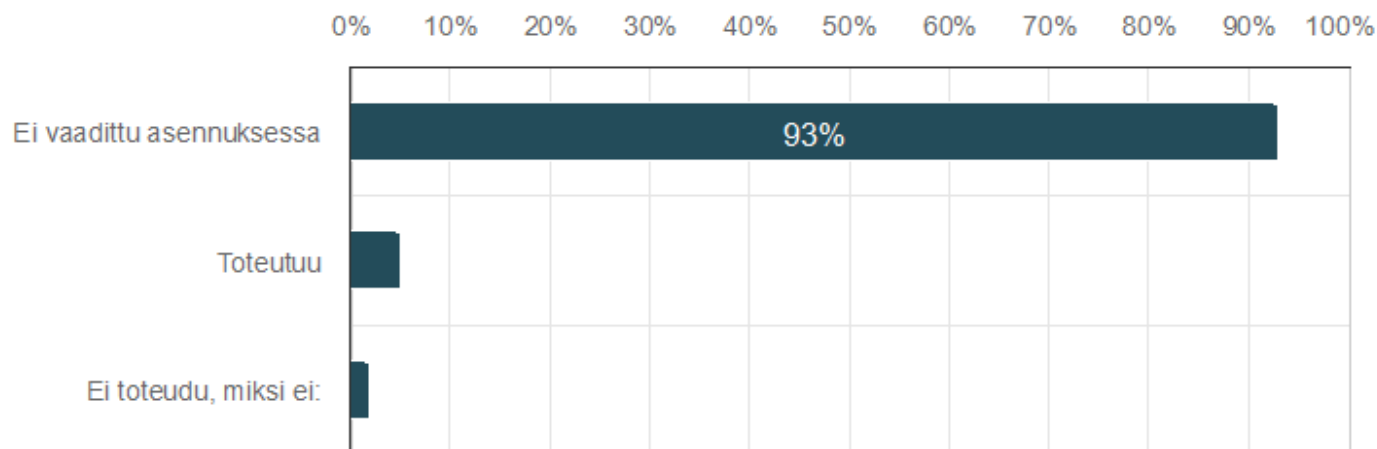
3.2 If required, the residual current protection (including 300 mA fire protection) of the alternating current part connecting the system must be implemented in compliance with the standard with a type B residual current device, with the exceptions allowed by the appropriate section of the standard (SFS 6000 712.530.3.101, SFS 6000 712.532.101)

- A type F residual current device has been installed. It was mentioned in the datasheet that a type B residual current device should be used.

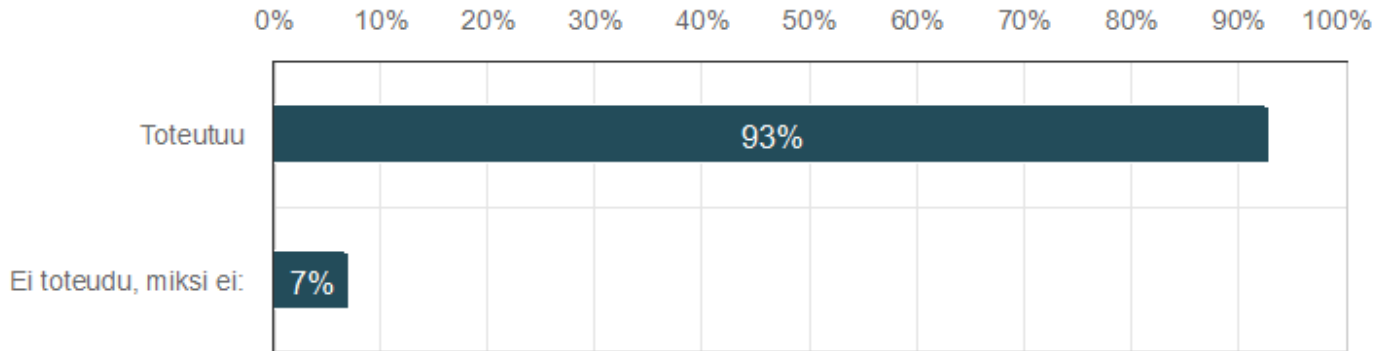
3.3 Compliance of overcurrent protection of the supply circuit with the requirements of SFS 6000 (SFS 6000 712.433.104, 712.434.101)

- The maximum output AC current of the inverter was 16.04 A. For overcurrent protection of the system, circuit breakers of the KEMA KEUR brand (E series), B curve 16 A, had been used, which had been mounted so that they touched each other. The design principles of the circuit breaker manufacturer for the dimensioning of continuous flow were insufficient for the rated current of the circuit breaker. According to the inverter manufacturer's instructions, the maximum fuse must be a type B or C 25 A circuit breaker. Choosing the right overcurrent protection device will cause the need to review the dimensioning of the AC wire.

- The inverter's maximum AC current was 20 A, design current 18.9 A. Overcurrent protectors 3 x 16 A C curve. The inverter's maximum current had not been taken into account.

- The maximum AC current was the same as the rated current of the circuit breaker. The rated value for continuous flow of the circuit breaker should be considered based on the manufacturer's instructions in a situation where several circuit breakers are installed in parallel.

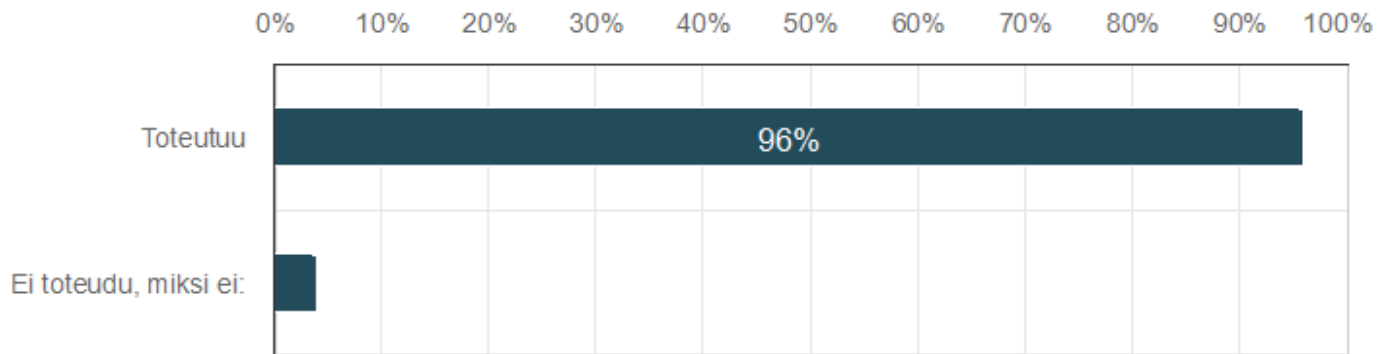
5.1 The photovoltaic installation must be equipped with a separation device that can be used to separate it from the public distribution network (SFS 6000 801.551).

- The separation point was inside the distribution board, should be outside.

- The isolating switch was inside, should be outside.

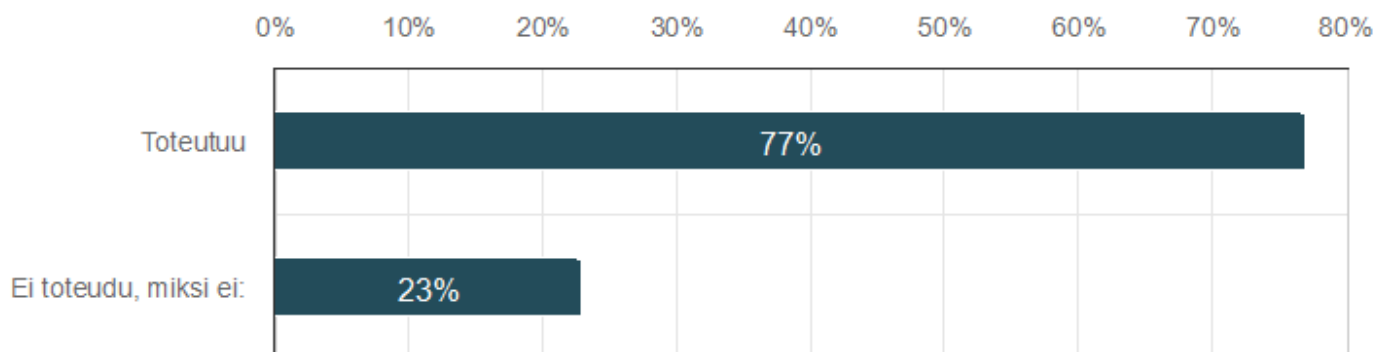
5.4 The components must be installed in accordance with the manufacturer's instructions and good installation practice. General requirements of SFS 6000 on enclosure, placement and environmental conditions must be met (including dust, farm environment, corrosive substances, water protection and direct sunlight).

- The installation cable to the roof from the board did not meet the thermal resistance requirements, as it had been installed under the roofing sheet. The ambient temperature can get really high under the black eaves sheet. The allowed maximum temperature for regular MMJ-type cables in continuous use is 70°C. This temperature can be reached on a hot summer day even without the cable load.

- Basic insulated conductors can be touched, screening requirement for the fuse box was not met.
- Plywood board had been used as the inverter mounting base. The manufacturer's instructions require a fire-resistant mounting base. The placement of the inverter or protection from direct sunlight should be checked, as the inverter had been installed at the western end where it was subjected to direct sunlight (the installation instructions require protection from direct sunlight). Furthermore, the inverter had not been protected from rainwater at the site in question (the manufacturer's installation instructions require protection from rainwater and splashing water).

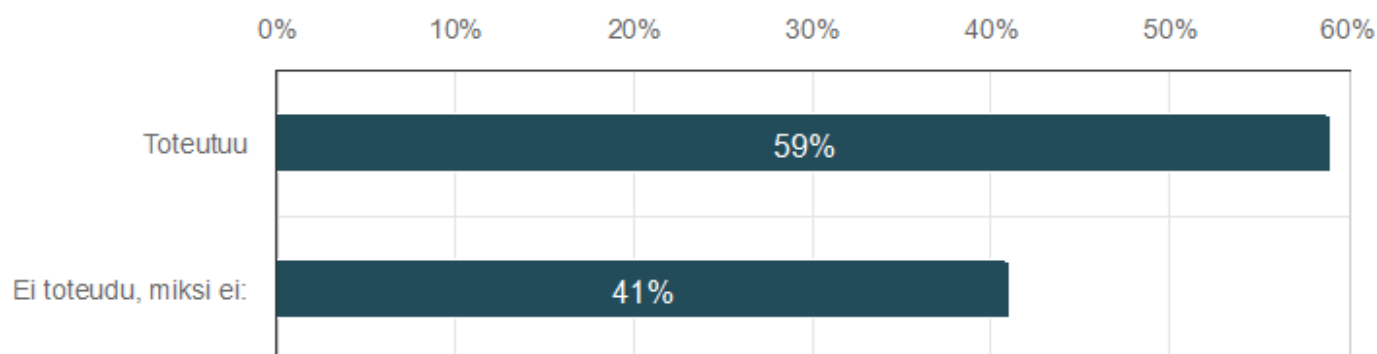
5.6 There must be fire-resistant materials behind and underneath the inverter and DC isolating switch if the base itself is not fire-resistant. If the fire-resistant material is highly heat conductive, a ventilated air space should be left between the fire-resistant material and the wooden mounting base (SFS 6000 712.420.101/2022 edition).

- A cover plate made from a fire-resistant material was missing from behind the DC isolating switch.
- The DC isolating switch was on top of a sheet of steel, which had been attached to a wall made from a flammable material.
- The inverter had been mounted directly on a timber wall.

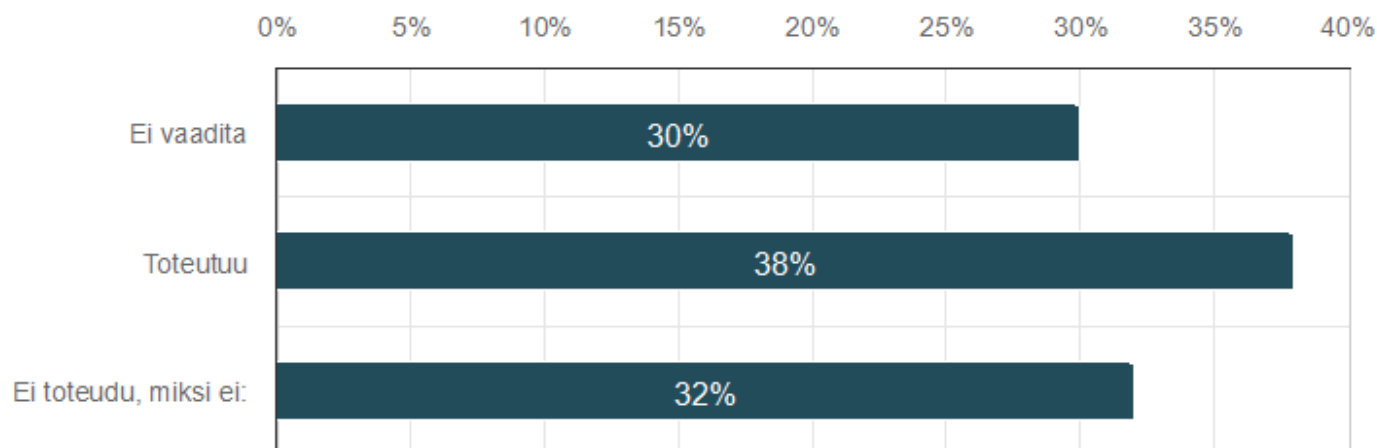
5.7 A requirement according to the 2017 edition of the SFS 6000 standard series (please note: only if the manufacturer's instructions require it).

- The inverter was on a wainscotted wall. Section 5 of the inverter's Installation & Operation manual requires the following: Do not install the inverter on a building constructed of flammable or heat-resistant materials.

- The inverter installation instructions prohibit the installation of the inverter on a flammable surface.
- The manufacturer's installation instructions instruct to select a mounting base that is not flammable, such as a concrete or stone wall. The inverter had been mounted onto a timber wall. Waterproof plywood had been placed in between the inverter and the wainscotting.
- The installation instructions state that the installation site must not contain any flammable or explosive materials. In addition, installation on a flammable wall is prohibited by an illustration. At the site, the inverter had been mounted onto board cladding.

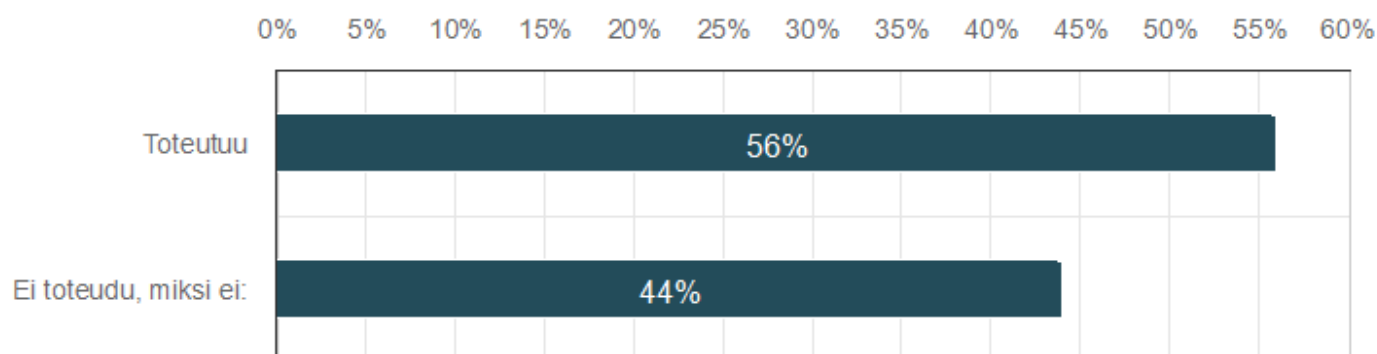
6.1 The installation of the wiring system (AC and DC) must comply with the general requirements on the installation of the wiring systems of low-voltage electrical installations in Part 5-52 of the SFS 6000 standard series (including mechanical protection, fixing and maximum capacity).

- Met otherwise, except that in the roof structures, the AC cabling was not fixed for a short distance (some 1–2 m) over the mineral wool insulation and the DC wiring on the roof touched the roof tiles under the panels.

- The alternating current cables between the inverters integrated into the panels had been installed against the roof surface. The cables had not been fixed in any way. The realisation of inverter connecting point strain relief could not be ascertained. Cable in between panels: a control cable of the type H07BQ-F 4 x 2.5 mm². The data sheets of corresponding cables promise UV resistance as well as a maximum operating temperature of 90°C. The panels had been chained together on the roof, with an unfixed junction box (AP 9) with supply from the building board on the roof under the panels. No earthing had been connected to the panel inverters. The cable from the board to the roof was an MMJ-type installation cable. The cable had not been fixed under the panels. Cabling from the roof down: snow barriers had been used as the installation route, with the cables tied onto them by cable ties. The cable was pressed against the sharp snow barrier mounting brackets. The rest had been installed under the eaves lead. The cable could be seen in between the eaves leads, partly against sharp sheet metal edges. In the case of these installations, the maximum capacity of the AC cables, the MMJ type cables in particular, should be investigated taking into account the ambient temperatures (under the roofing sheet and under the panels). In addition, the UV resistance of the MMJ-type cable should be checked. (There are differences between models. The exact type of cable used could not be ascertained.)

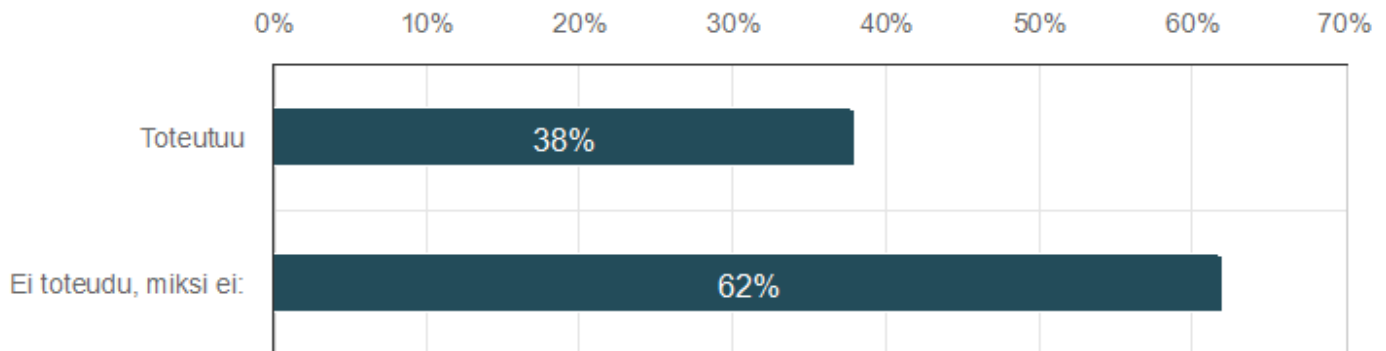
6.2 The cabling of the DC part must be realised using single-conductor cables without metal sheathing or insulated conductors installed separately in electrical conduits made from an insulating material. Cables are not to be installed directly onto the roof surface (SFS 6000 712.521.101).

- There were no DC cables at the site. The AC cables had been installed without fixing and support directly under the panels against the roof surface, subject to external stresses (snow, ice, water). In addition, the MMJ-type cable had been fixed onto a snow barrier with cable ties, partly against sharp sheet metal edges. The requirements of Part 522 of SFS 6000 had not been taken into account in the AC cabling (Section 522.8 and its subchapters in particular).

- The cables lay freely against the roof surface without any mechanical protection and fixing.
- On the roof, the DC wiring was touching the roof under the panels in some places.

- The cabling in between the panels was hanging and touching the roof surface. In addition, the DC cables to and from the roof were partly against the roof surface/inside and in between the roof structures without any mechanical protection. Some of the mechanical protection components used in the installation posed a risk of cutting damage to the cable sheath.

- There were DC cable loops hanging under the panels.
- There were DC cable loops hanging under the panels on the roof and wall.
- The cables had been laid against the roof surface. Mechanical protection of the cables was defective.

- Some of the DC cables were directly touching the roof surface.

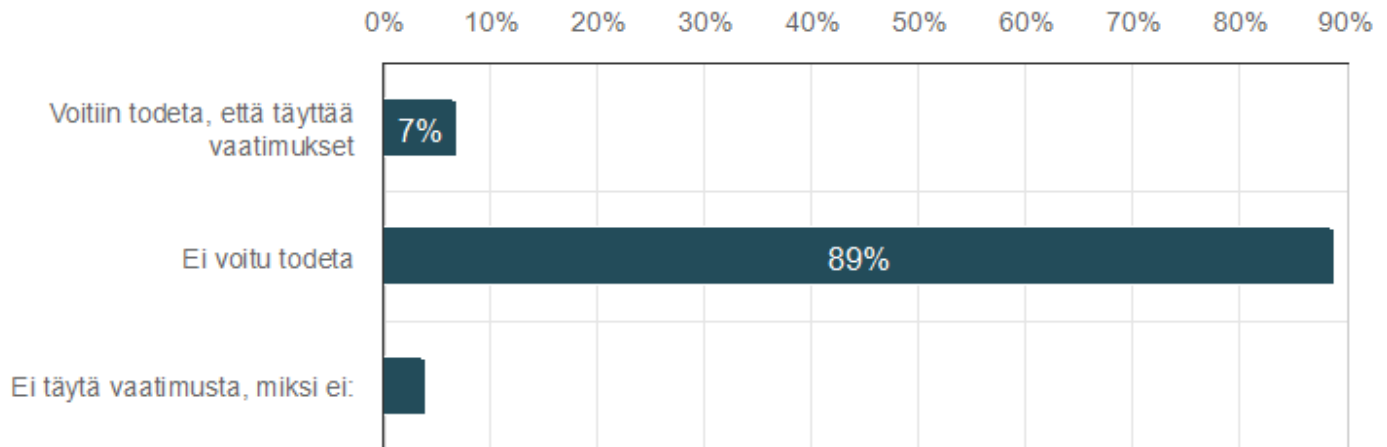
7.1 The connector pairs of the DC part must be electrically and mechanically compatible and suitable for the operating environment (SFS 6000 712.526.1/2017 edition).

The plug and socket outlets and connectors of the DC part must be of the same type and from the same manufacturer. Products from different manufacturers must not be used in the same connection (SFS 6000 712.526.101/2022 edition).

- The MC-4 connectors were from different manufacturers. For this reason, the requirement on the electrical and mechanical compatibility of the connectors was not met without mutual declaration of compatibility by the manufacturers. MC-4 is not a standardised connector type, so there can be significant differences in the dimensions and materials of connectors by different manufacturers, as a result of which the requirement on electrical or mechanical compatibility was not met. Both defects can result in a chain reaction causing increased transfer resistance of the connection point and spot heating over time, which can even cause a building fire risk.

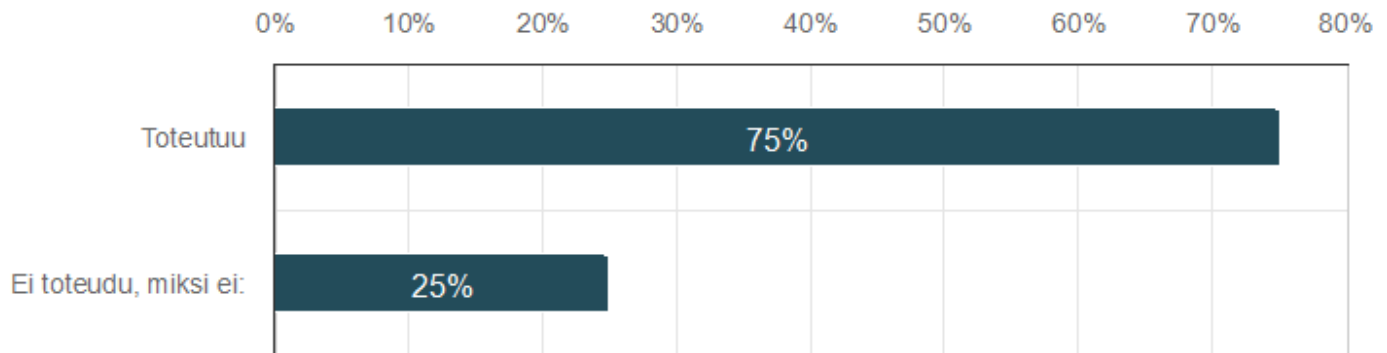
8.1 Whenever necessary (required by the manufacturer's instructions), equipotential bonding must be realised in accordance with the equipotential bonding instructions in the SFS 6000 standard series. Metal support structures of the panels and metal cable routes must be connected to the equipotential bonding (SFS 6000 712.542.101/2017 edition).

- The copper conductors had been fixed directly onto an aluminium rail by squeezing them in between a bracket. A copper-aluminium connector pair is not suitable without a bimetallic aluminium/copper connector such as a suitable cable clamp. Otherwise, the requirement was met.

- Installation instructions for the panels and the integrated inverters were not available. It was not possible to verify the earthing instructions. There was no earthing connected to the inverters.

- The equipotential bonding requirements were otherwise met, but the inverter had not been connected to the equipotential bonding in accordance with the inverter installation instructions.

- The manufacturer recommends equipotential bonding for the photovoltaic arrays. The panels and their frames were not connected to equipotential bonding. (Please note: This is a recommendation in the panel manufacturer's installation instructions, not a requirement.)

- The equipotential bonding conductor had been installed from the inverter body only to one of the panel mounting systems (The panels were in one circuit but mounted as two separate entities on the roof. However, there was continuity through the fasteners and via the sheet metal roof also for the busbars without equipotential bonding.) Equipotential bonding between the inverter and the board relied on the protective earthing conductor of the MMJ 5 x 2.5 cable (the cable's cross-sectional area should be 6 mm²).

- Equipotential bonding had not been done!

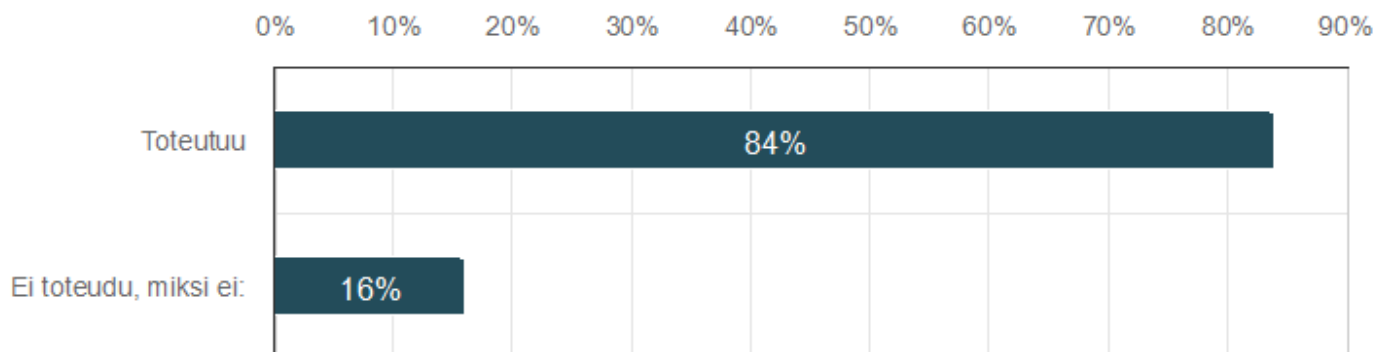
8.2 If the voltage of the photovoltaic array is less than 60 V, equipotential bonding is not necessary; otherwise, according to the relevant section of the standard. Equipotential bonding and any other conductive parts close to them must be connected (copper, 6 mm² or 16 mm², if there is an external lightning protection system) to the equipotential bonding (SFS 6000 712.542.101/2022 edition).

- Equipotential bonding was missing from the photovoltaic array support structures
- There was no equipotential bonding for the photovoltaic array at all!

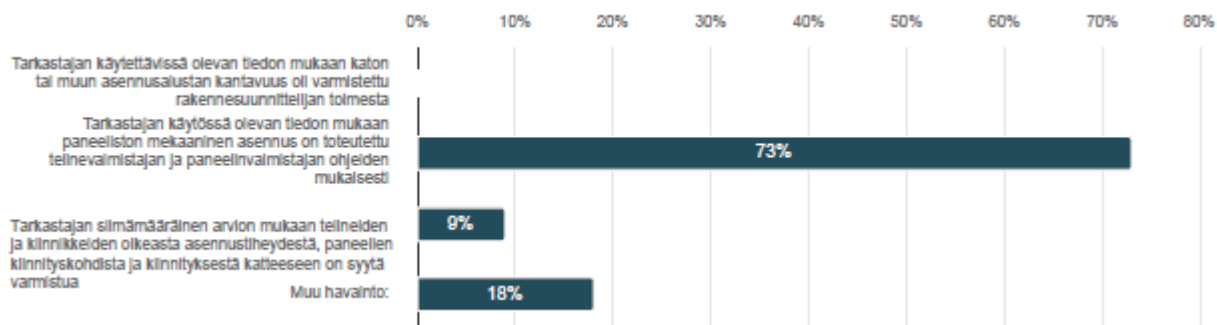
9. ASSESSMENT OF THE MECHANICAL INSTALLATION OF THE PHOTOVOLTAIC ARRAY

- The panels and the racks seemed securely fixed. Based on the data sheet for the panels, the mechanical resistance of the panels against snow and wind was also sufficient. The fixing of the racks to the roof or roof battens could not be verified. All the fixing elements were under the panels. According to the possessor, no construction drawings or other information on the building to ensure mechanical resistance had been requested from them.

- The mechanical installation could not be verified because there was no safe access to the roof, and there was no possibility to attach fall arrest equipment. The panels and cables were visually inspected from a ladder at the eaves.

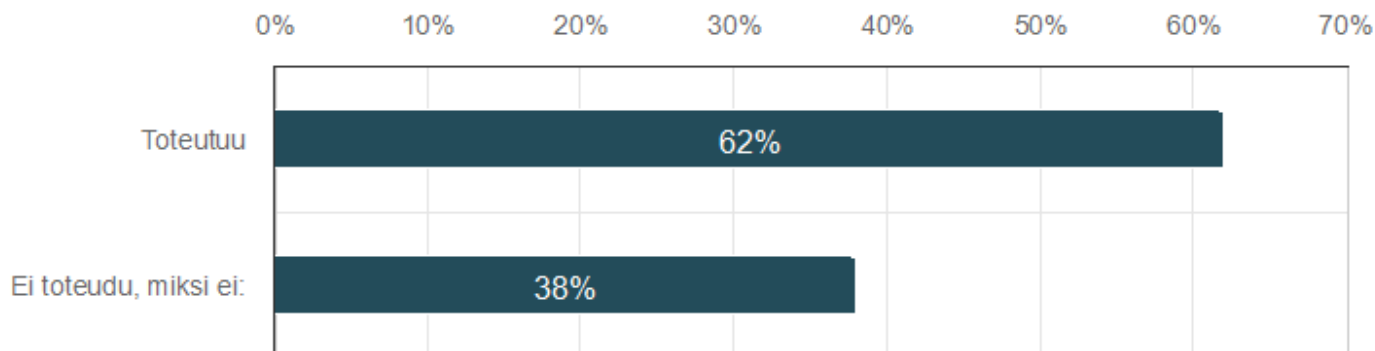
10.1 The system must include warnings on a photovoltaic system installed in the building at, for example, the electrical installation connecting point, the electrical energy measurement point and the switchboard supplied by the inverter (SFS 6000 712.514.101, Fig. 712.514.101).

- The photovoltaic installations had not been marked or documented at all. The system connecting point (a distribution board) did not have any markings (on fuses or warning markings) related to the photovoltaic system. Also, there was no warning label about the photovoltaic system in the property's main distribution board.

- There was no warning label for the photovoltaic system in the main distribution board.

- The possessor had no other documentation for the installations in addition to the commissioning inspection record, the datasheet of the panels and the datasheet of the inverter. Board markings had not been updated in the fuses of the inverter's connecting point. There was no warning label on the photovoltaic system at the site.

- Power panelboards did not have any warning labels on the photovoltaic system.

- Met now; the markings were added in arrears by a local electrical contractor.

- The main distribution board included a warning about reverse polarity voltage, but not on the photovoltaic system.

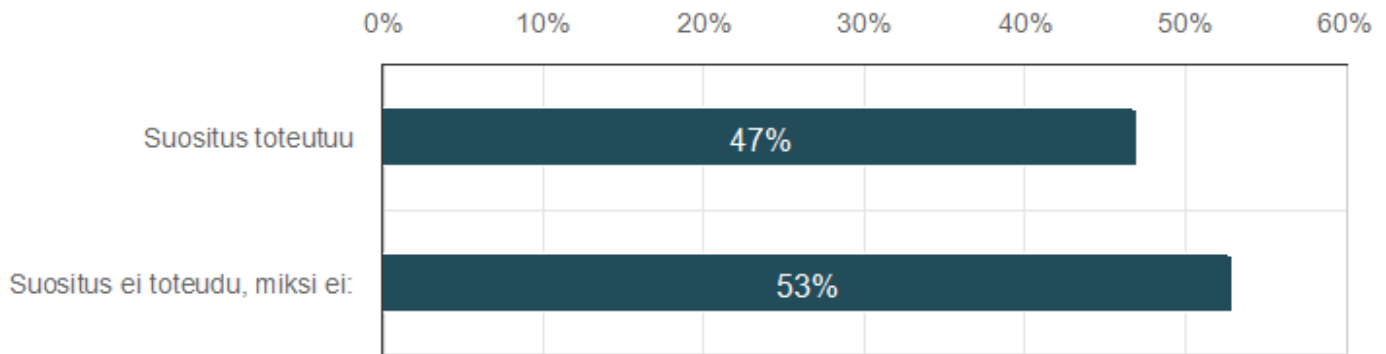
10.3 Inverters should bear a label stating that the inverter must be separated from both the DC part and the AC part before any maintenance activities (SFS 6000 712.514.103).

- The site did not include any operating and maintenance instructions, markings or warning texts related to the photovoltaic system.
- The inverters were integrated into the panels. No information on their markings was available, as the microinverter cannot be accessed while the panel is attached. In addition, there was a separate control device (IQ ENVOY) that identifies microinverters and gathers information, which was unmarked.
- Markings were missing.

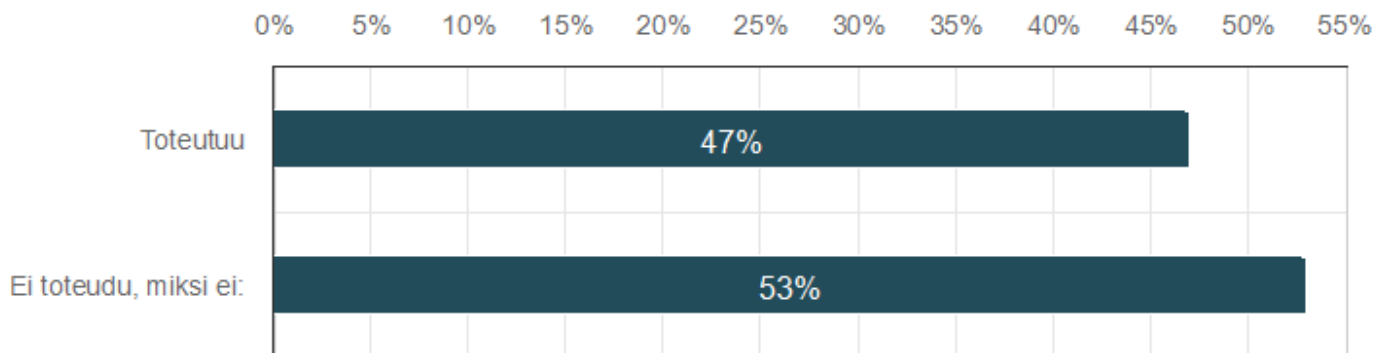
11.1 An instruction manual for the photovoltaic system must be available, including instructions on de-energising the system and using any accumulators (SFS-EN 62446-1).

- No documentation on the installation or the system had been handed over to the possessor. Commercial documents only, showing only the type of the panels. The panel type was checked at the site. The system components were neither marked nor documented.
- Only a short maintenance manual for photovoltaic systems, prepared by the electrical contractor, was available, but it did not explain the operation of the brand-specific inverter, for example.
- There was no instruction manual at the site nor any instructions on the photovoltaic system.
- The instruction manual had been “misplaced”, could be found online if necessary.
- There was no instruction manual.
- No operating instructions had been delivered to the customer.
- There was no instruction manual or any emergency stop instructions. Only an incomplete commissioning inspection record had been provided for the installation.

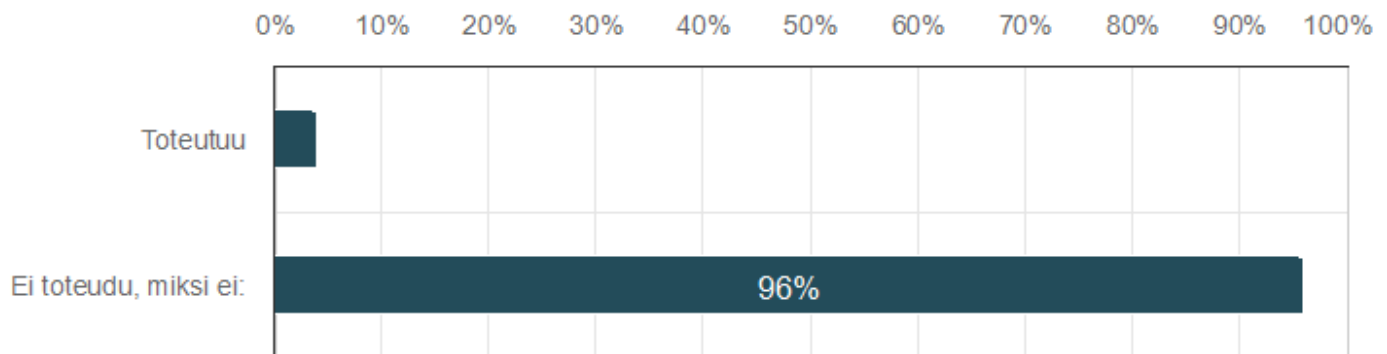
11.2 Changes to the electrical circuit markings and drawings due to the installation of the system must be properly implemented (documentation according to SFS 6000 514.5), and there must be a wiring diagram for DC installations, for example (SFS-EN 62446-1 4.3).

- There was no DC installation wiring diagram available.
- There were no drawings available. Group markings on the address labels in the main distribution board were fine.
- There were no drawings or diagrams.
- The possessor did not have any documentation related to the system. The changes had not been updated in board markings, for example.
- The information of the photovoltaic system or circuit diagrams had not been added to the building's circuit diagrams.
- Circuit diagrams for the photovoltaic system were available. There were no circuit diagrams for the building's electrical equipment (built in the 1950s).
- The diagram of the photovoltaic system was not completely correct.
- Diagrams had not been updated.
