# Fire at a transformer plant in Vaasa

Finnish Safety and Chemicals Agency (Tukes)

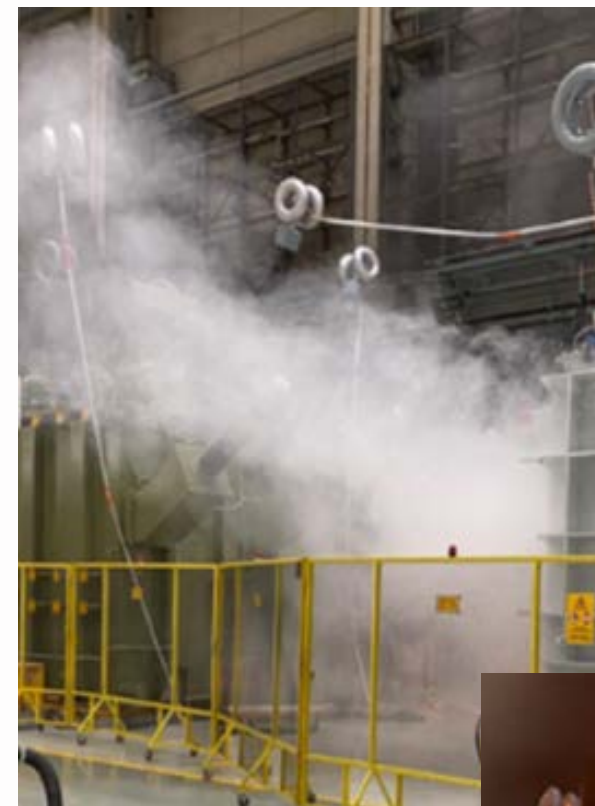
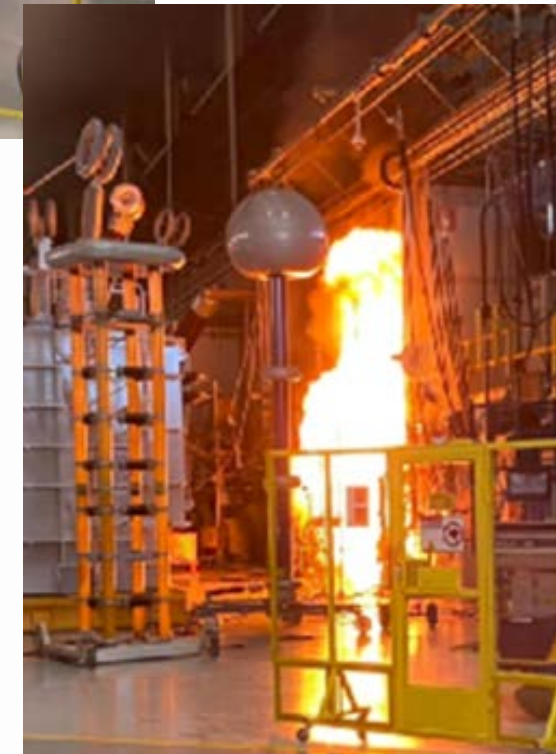
- When the voltage was increased, the senior tester paid attention to fluctuations in voltage; voltage did not seem to change according to potentiometer adjustments.
- At the same time, the senior tester heard a sound like a “faint thump” through a window that was open in the control room.
- The senior tester quickly started to lower the voltage.
- The tester saw smoke down in the test field.
- The senior tester de-energised the test field and closed the reactor’s oil valve.
- Hand-held extinguishers were insufficient to put out the fire.
- Automatic fire alarm
- When units arrived at the site, no smoke could yet be seen from the outside, which is why the first steps were taken in accordance with the expected alarm incident.

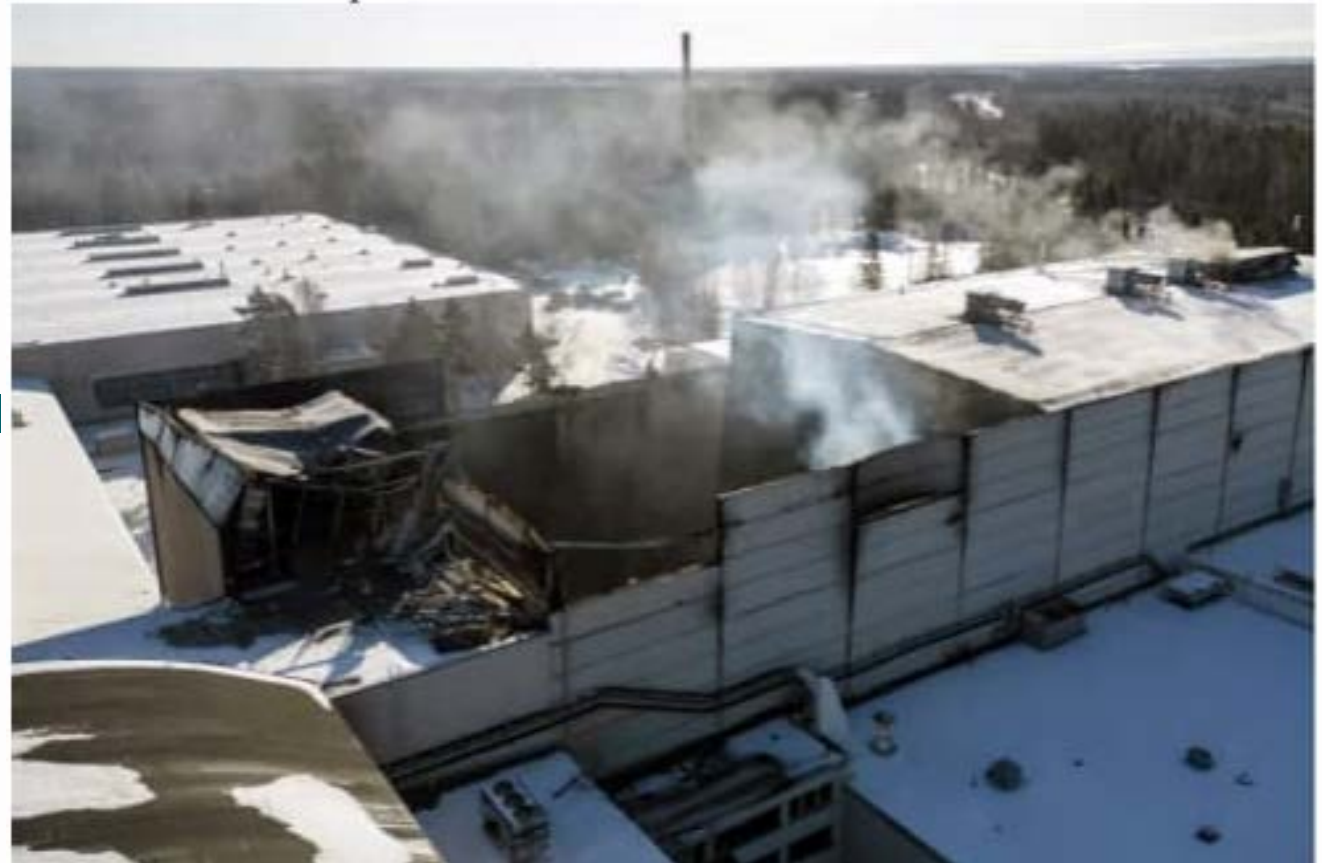
- When rescue units arrived at the site, no smoke could yet be seen from the outside, which is why the first steps were taken in accordance with the expected alarm incident.
- Exhaust fans fell on testing transformers, breaking their structures => more oil to fuel the fire.
- The roof collapsed, improving visibility and preventing flue gases from igniting.
- The site was guarded afterwards for several weeks; small fires started and structures this time.

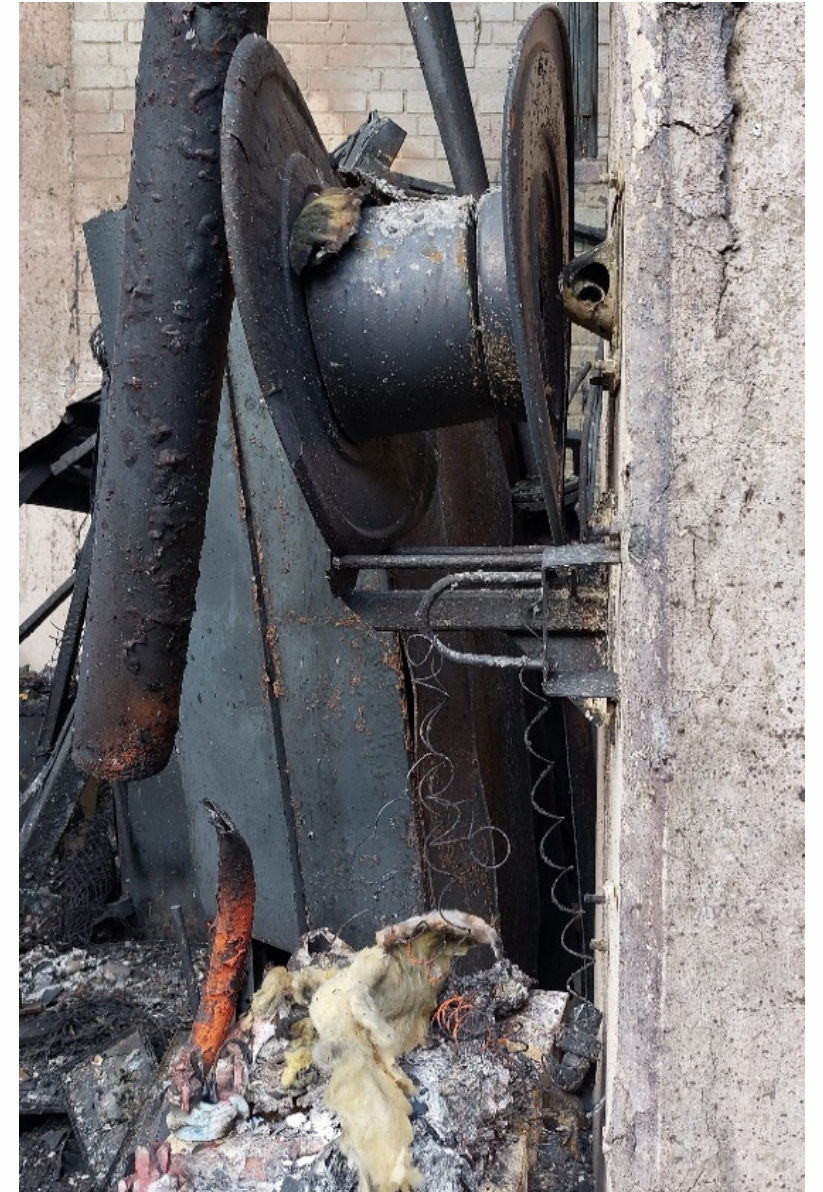
- The fire started because the expansion hose for transformer oil failed when its reinforcing wire heated and melted parts of the rubber hose.
- The reinforcing wire heated because one of the grounding cables was probably not connected.
- The device was grounded through the expansion oil hose, and the current heated the reinforcing wire, igniting the hose.
- Oil leaked into the fire from the expansion tank through the damaged hose, causing the fire to spread.

- The device was moved several times during testing so that some groundings had to be disconnected and reconnected. This was necessary because of the test facility's spatial solutions.
- The location of any shut-off valves could not be identified during the investigation, and there was no other safety device in the line to stop the oil leak. As a result, oil leaked gravitationally on the floor from the expansion tank when the expansion hose failed.
- The test involved a reactor whose testing output required during testing is ten times higher compared to a transformer of the same size. As a result, the current flowing through the expansion hose was also higher.
- Exhaust fans falling on transformers, breaking their structures, increased the amount of oil fuelling the fire. This caused the situation to escalate into a large fire.

- The test facility must be designed so that the device does not need to be moved during testing.
- A system that signals the lack of grounding/prevents testing in the absence of grounding must be deployed.
- Shut-off valves must be added to pipelines in easily accessible locations; possibly equipped with automatic shut-off after a fire alarm/emergency stop or overflow valves.
- The functioning of emergency stop buttons in accidents and emergencies must be consistent.
- The purposefulness of safety-based access restrictions in accidents and emergencies must be consistent and clear.
- Chemicals that have not been classified as flammable liquids and that may contribute to a fire and thus increase the fire load must be addressed in risk assessments and management.
