Accident at AT-Tuote Oy Sipoo facility

March 2nd, 2018

Accident Investigation Report
dnro 4044/00.05.12/2018

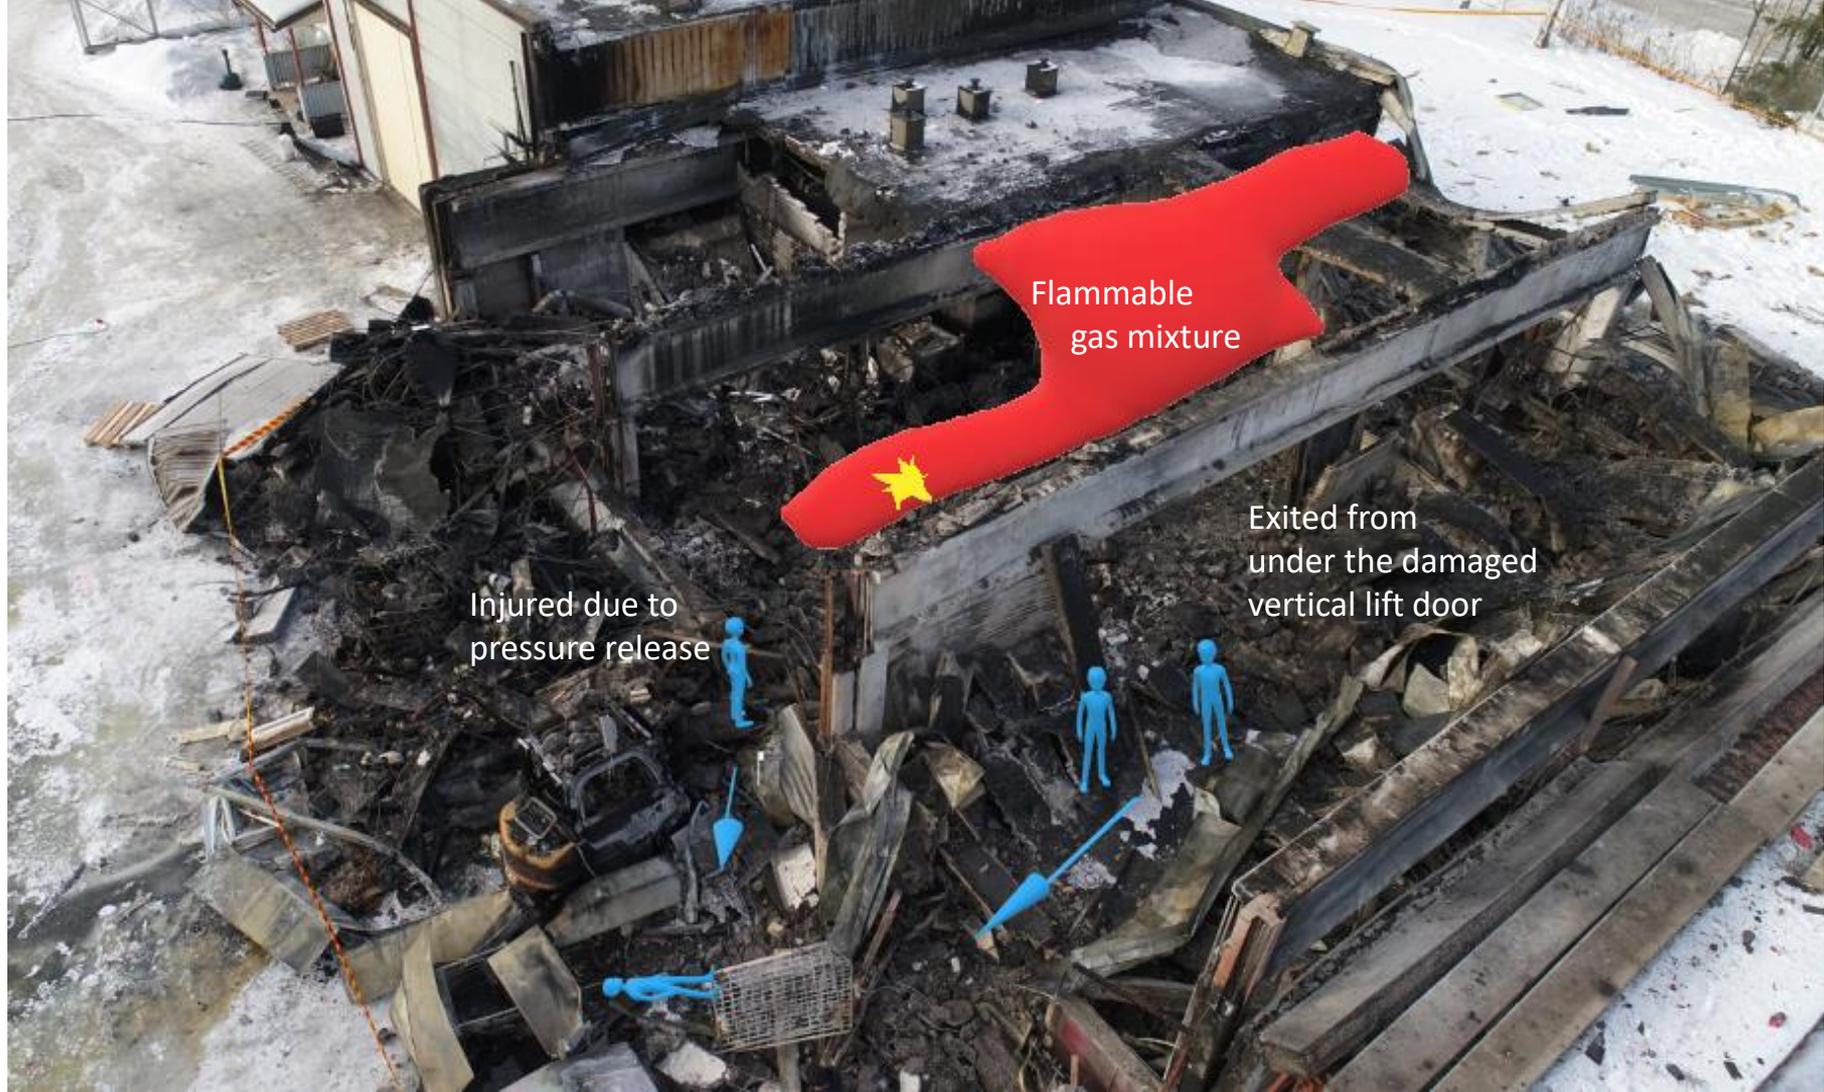
- The source of the leak could not be identified with certainty
- It is deemed probable that due to inadequate ventilation solvent vapours or flammable gas accumulated in the upper parts of the building.
- Ignition was probably caused by the stopping mechanism of the vertical lift door, static electricity or an electrical appliance.
- According to the workers inside the building, the indoor gas detectors did not sound an alarm before the accident.

Flammable
gas mixture

Injured due to
pressure release

Exited from
under the damaged
vertical lift door

- Adequacy of ventilation must be monitored regularly
- Pressure relief must be designed and carried out so that the buildup of pressure cannot cause collapse of structures or buildings, or damage to pipelines
- There must be enough gas detectors in facilities where explosive mixtures may be present
- Alarms from gas detectors must be detectable in all places where workers may be in danger and near entrance doors.
- Vertical lift doors are not suitable as emergency exits
- The amount of hazardous chemicals in the production facilities should be limited to be as low as possible (e.g. the needs of one shift).
- It is recommended to attach the gas alarm to the safety automation system, e.g. to de-energize electrical equipment and close valves
