Karoliina Meurman
8 March 2018

AGEING STUDY ON SMOKE ALARMS

FINAL REPORT

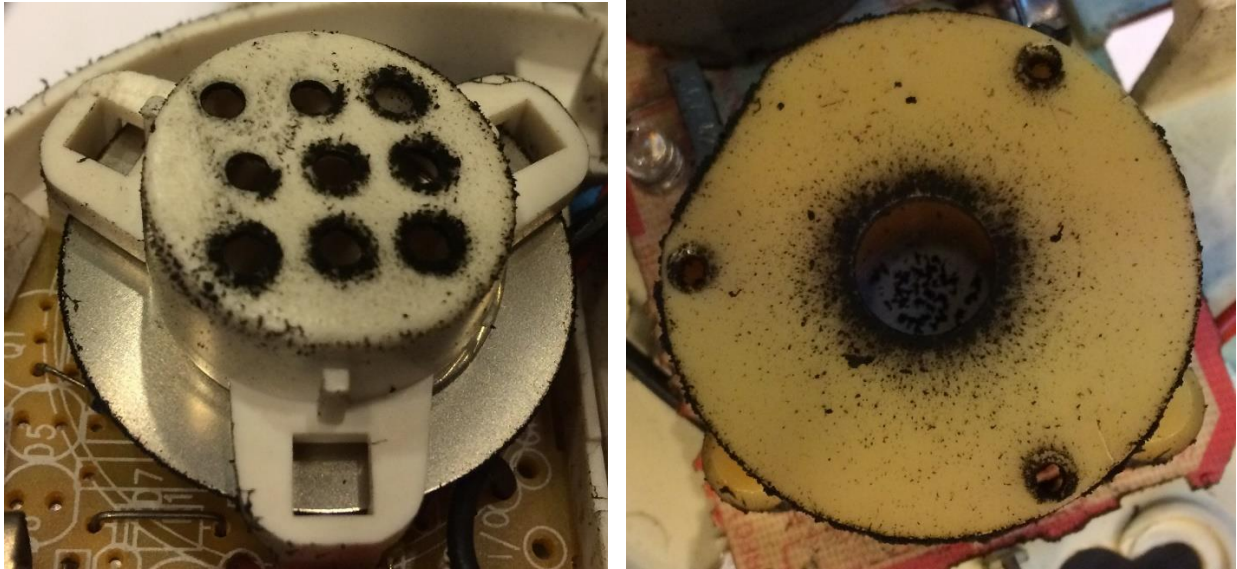
The smoke alarms were sooty after the test fires. Soot was gathered near the buzzer, in particular, due to the sounding of the alarm (vibration caused by the speaker).

Figure 10. Dirt near the buzzer after testing

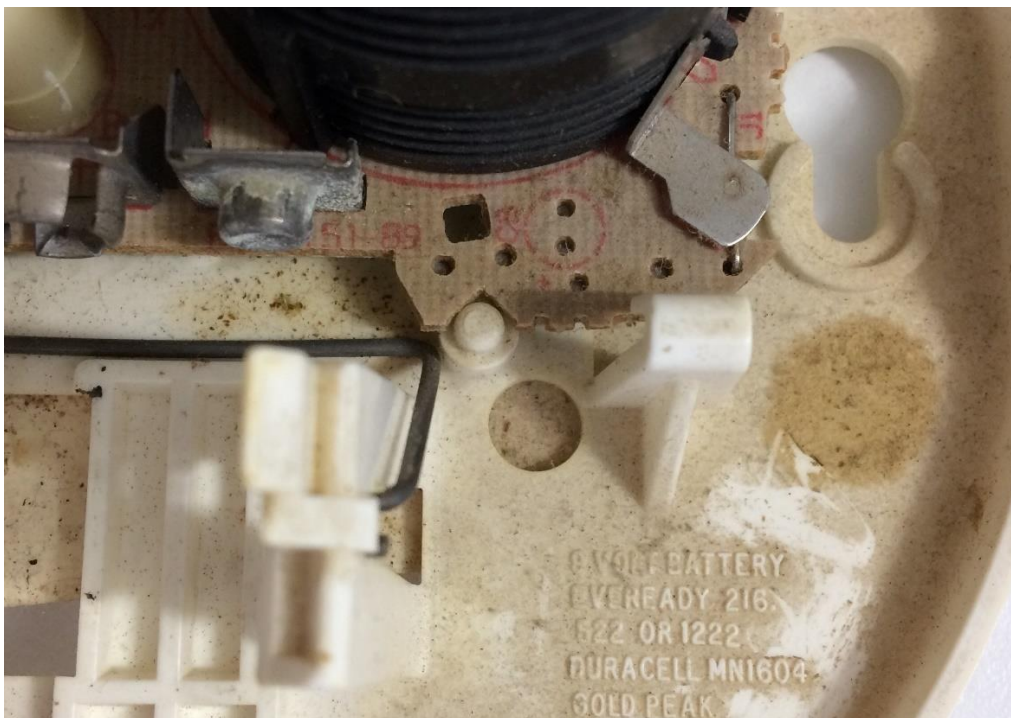
Before testing, the smoke alarms were opened. Some smoke alarms were observed to be very dirty inside. The most dirt was found inside the oldest smoke alarms. Corrosion was found on metal components perhaps due to uneven humidity conditions (holiday homes).

Figure 11. Dirt inside a smoke alarm

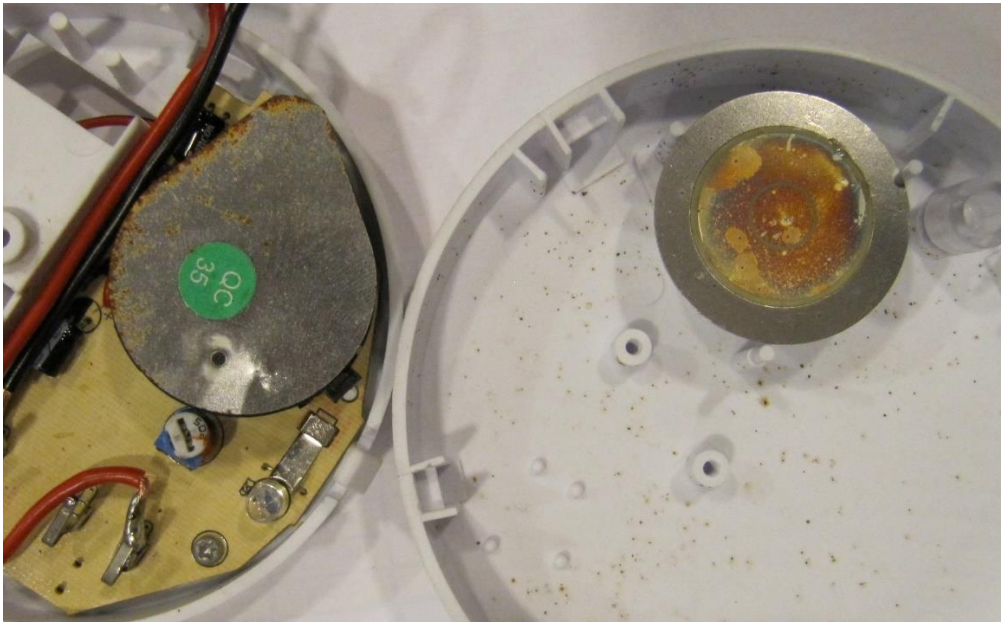
Figure 12. Dirt and corrosion inside a smoke alarm placed in a holiday home. On the left, a corroded detection chamber cover and on the right, a corroded buzzer.

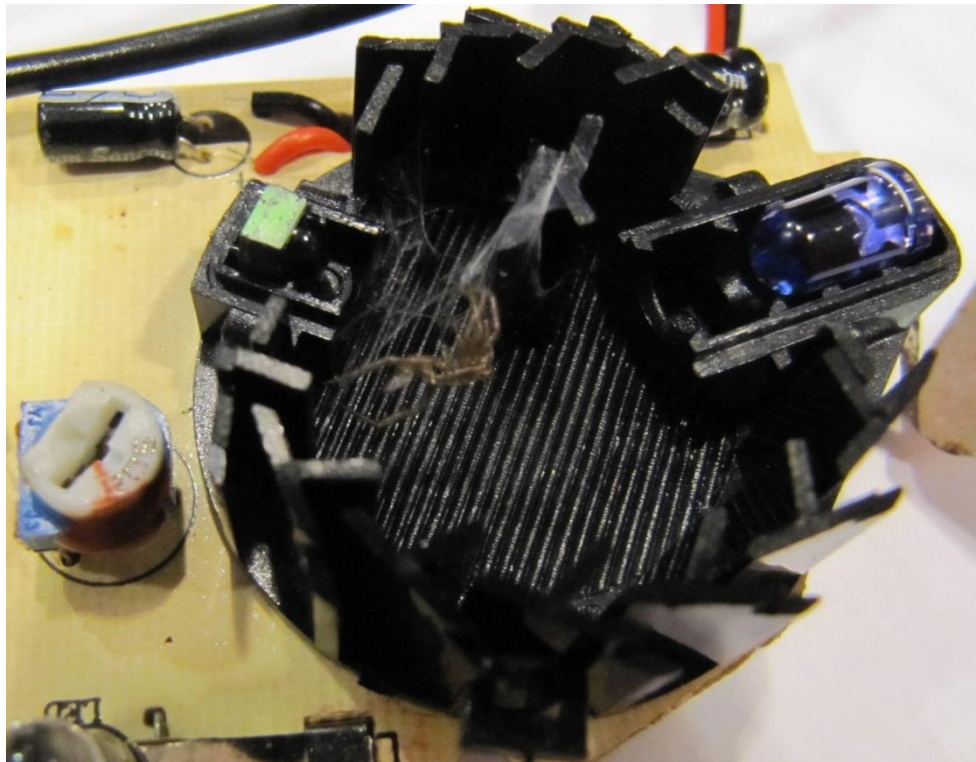
One of the smoke alarms began to sound the alarm after the battery was connected. A dead spider was found inside this smoke alarm.

Figure 13. A dead spider inside the detection chamber of an optical smoke alarm
