APPENDIX 1.

1. COMMISSIONING INSPECTION TO ENSURE THE SAFETY OF THE INSTALLATION AND RELATED DOCUMENTATION

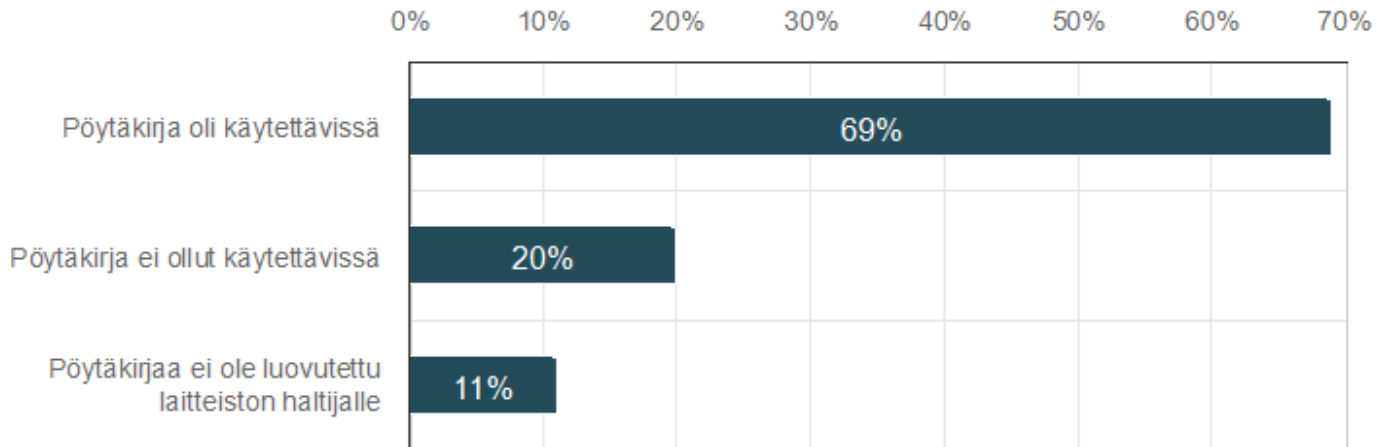
1.1 A commissioning inspection record in accordance with the Electrical Safety Act (1135/2016) was available during the inspection, with which the installer confirmed that the installation met the relevant safety requirements:

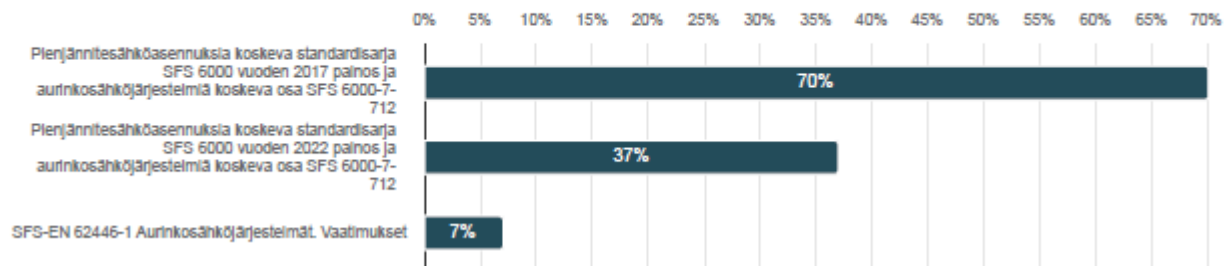
1.2 Standards indicated in the installation commissioning inspection record (list S-10 of the Finnish Safety and Chemicals Agency):

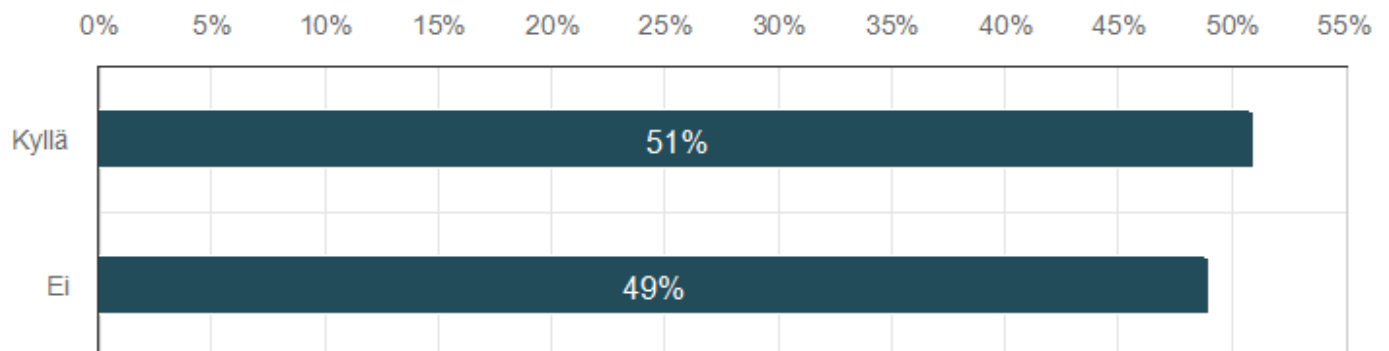
2.1 The record included the information required by the Government Decree on Electrical Installations (1434/2016, sections 4 and 5):

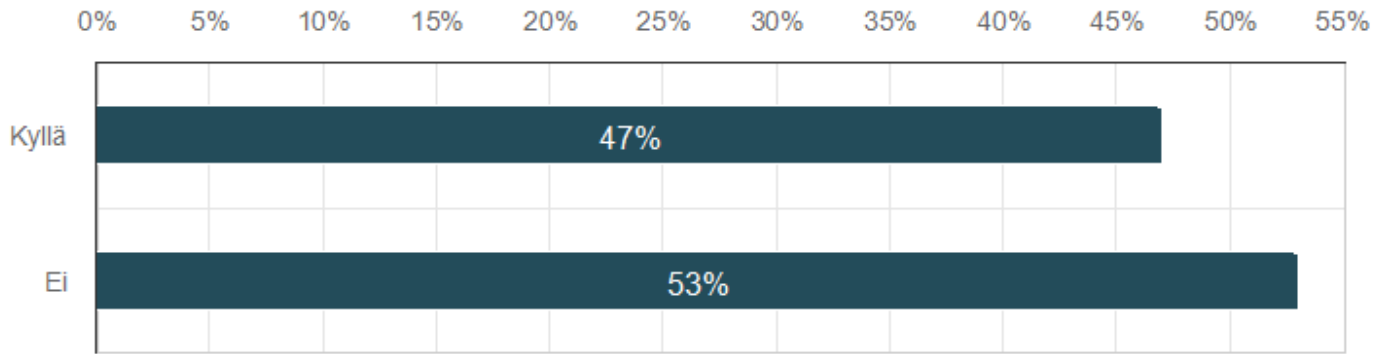
2.2 The record indicated the inspections and tests to be carried out during a commissioning inspection in accordance with Part 6 of the SFS 6000 standard on low-voltage electrical installations, together with the results:

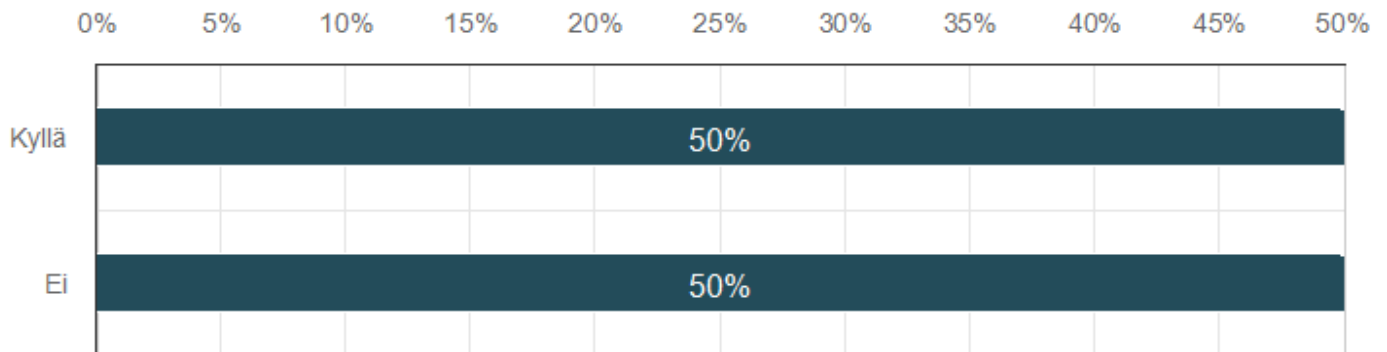
2.3 The record indicated the visual inspections of the photovoltaic system required by SFS-EN 62446-1 and documented Category 1 commissioning tests and inspection results (SFS 6000 712.6.101):

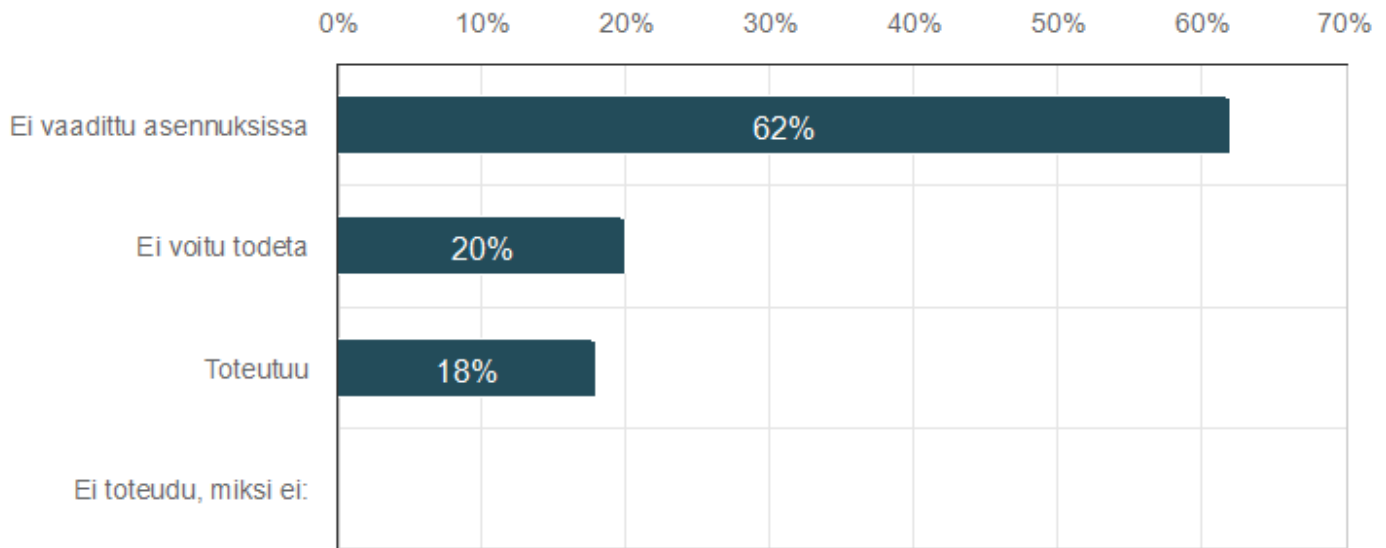
3.6 The overcurrent protection of the direct current part must be based on a gPV fuse or a fuse combination unit or switch in compliance with the applicable section of the standard (SFS 6000 712.533.101)

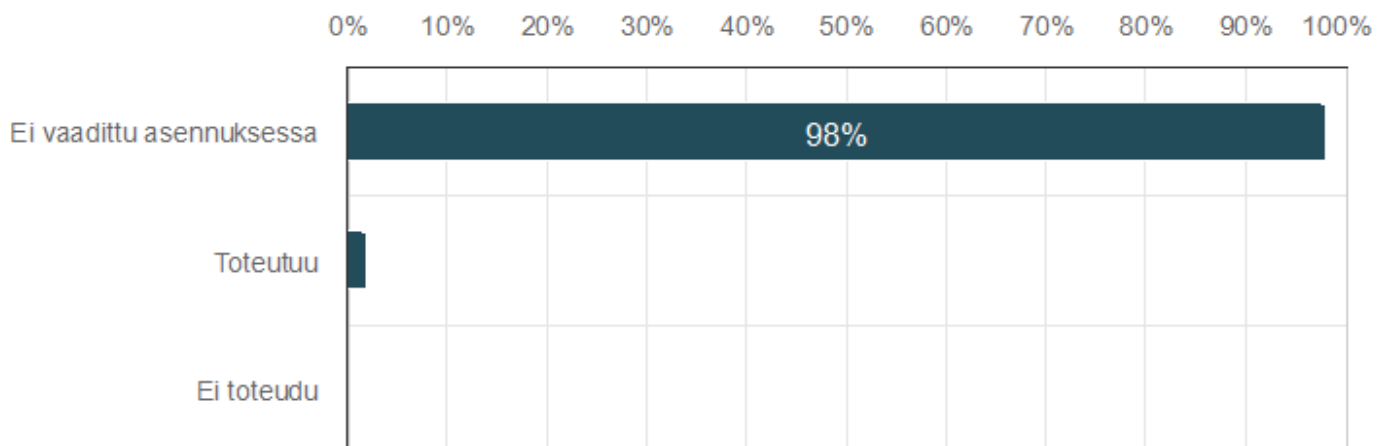
4.2 If necessary, there must be overvoltage protection of the alternating current part (risk assessment – lightning density, connected to an overhead cable network). The inverter must be located more than 10 m from the installation connection point, the surge arresters installed at the installation connection point must not be installed close to the inverter (SFS 6000 712.534.103).

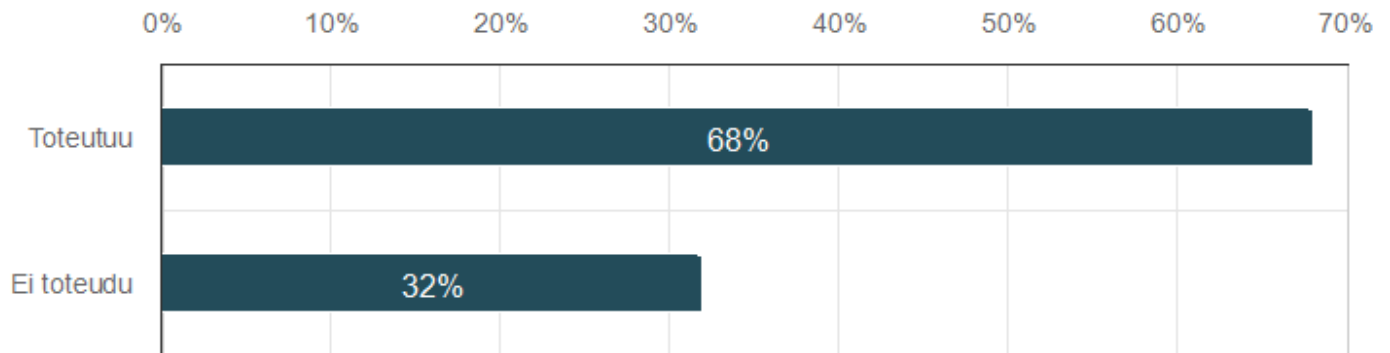
10.2 All devices in the DC part with live parts that can be accessed must be labelled with, for example, the text “Photovoltaic DC – live parts may be energised after separation” (SFS 6000 712.514.102).
